# Morrison Building Consultants Ltd

## Pre Purchase House Inspection

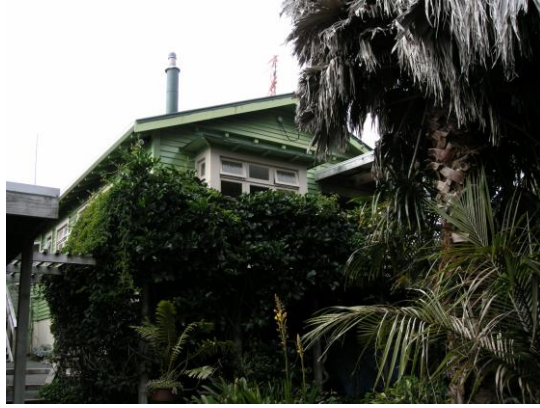
The site, while moderately sloped is extensively planted and landscaped. Coming after a reasonably wet winter and recent rain, the site seems well drained and surprisingly dry. There is certainly nothing apparent about the site or it's surrounds that would give rise to any present or future concerns.

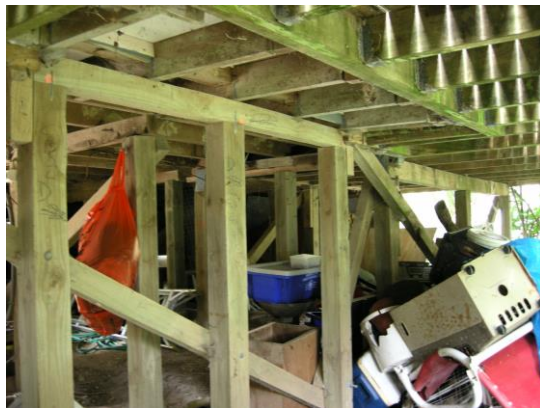
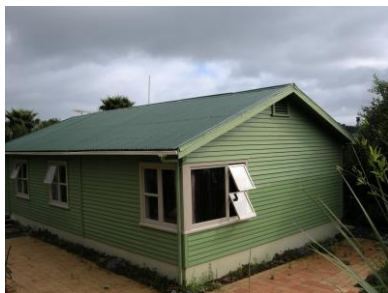
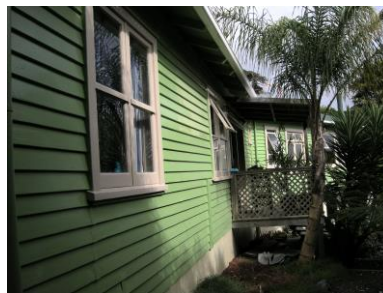
Under the house is dry and well ventilated. Tongue and groove timber floor, joists and bearers are sound and in good condition. New piles are straight, true and show no sign of ground movement. Joists and bearer connections are typical of the requirement of the day. An attempt has been made to insulate under the floor with 12mm polystyrene. One would doubt whether this would have much effect, but is better than nothing.

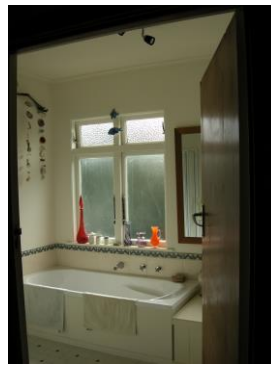
Everything about the interior would suggest a well built and maintained structure. Everything sound and true and in good order. Wet areas ie bathroom, laundry, are in good order. Kitchen is also relatively new and in good condition.
