# Morrison Building Consultants Ltd

## Pre Purchase House Inspection

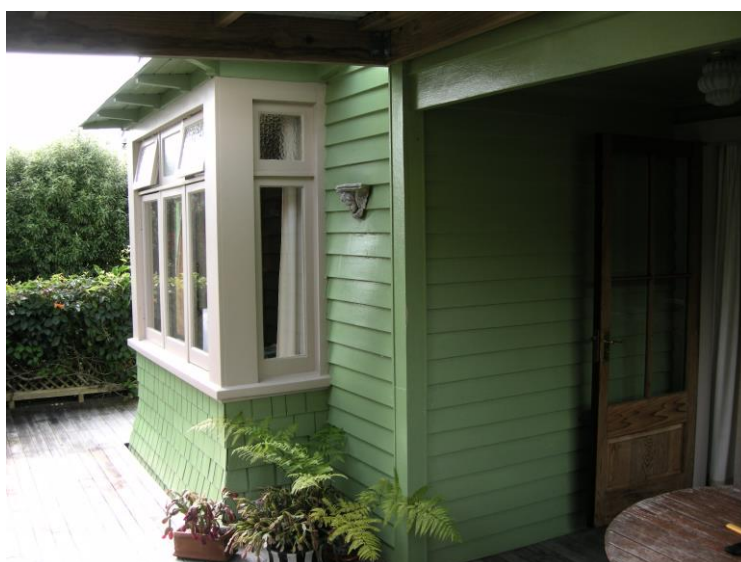
The House inspected is of a conventional timber construction with timber weather board cladding, wooden joinery and corrugated iron roof.

Originally built about the 1940's, with later additions, it was relocated to it's present site around 16 yrs ago. Therefore the basic infrastructure, ie foundations, water tanks, waste water system, power , telephone etc, were approved, constructed and council inspected at this time.

Since the relocation extensive renovation and restoration has been undertaken competently, and to a high standard and in no way compromises the integrity of the structure.
